Performance Evaluation of the Russian SPT-100 Thruster at NASA LeRC

John M. Sankovic, John A. Hamley, and Thomas W. Haag
Lewis Research Center
Cleveland, Ohio

Prepared for the
23rd International Electric Propulsion Conference
cosponsored by the AIAA, AIDAA, DGLR, and JSASS
Seattle, Washington, September 13-16, 1993

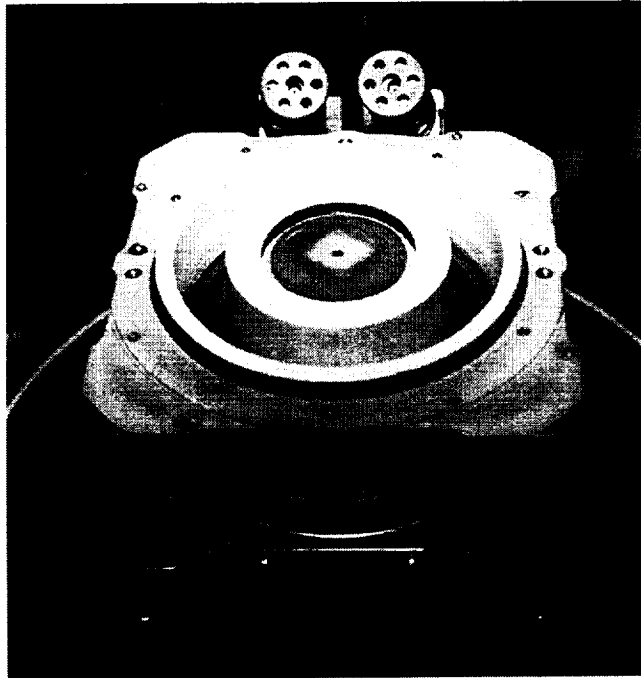
Figure 1.—SPT-100 thruster before operation at NASA Lewis Research Center.

All testing was performed on a single SPT-100 thruster S/N 002 provided by the BMDO. The thruster is designed to operate with a discharge current of 4.5 A and a discharge voltage of 300 V. A description of the thruster operating principles is provided by Brophy, *et al.*¹, and a comprehensive review of closed-drift thruster technology is provided by Kaufman.¹² The thruster was manufactured by Fakel Enterprise in Kaliningrad, Russia. The SPT-100 was essentially new and had undergone only initial performance testing at the manufacturer. After initial check-out, the thruster insulator was cleaned by the manufacturer, as was customary before delivery. A photograph of the thruster in as received condition is provided in Figure 1. The thruster was supplied with two cathodes, with only one required for operation.
